# **GEOTECHNICAL DESIGN REPORT**

**ARROYO CROSSING  
TRACT E &  
LOTS 20, 26, 29, 30, 37, 46 & 47  
GRAND COUNTY, UTAH**

**August 6, 2023**

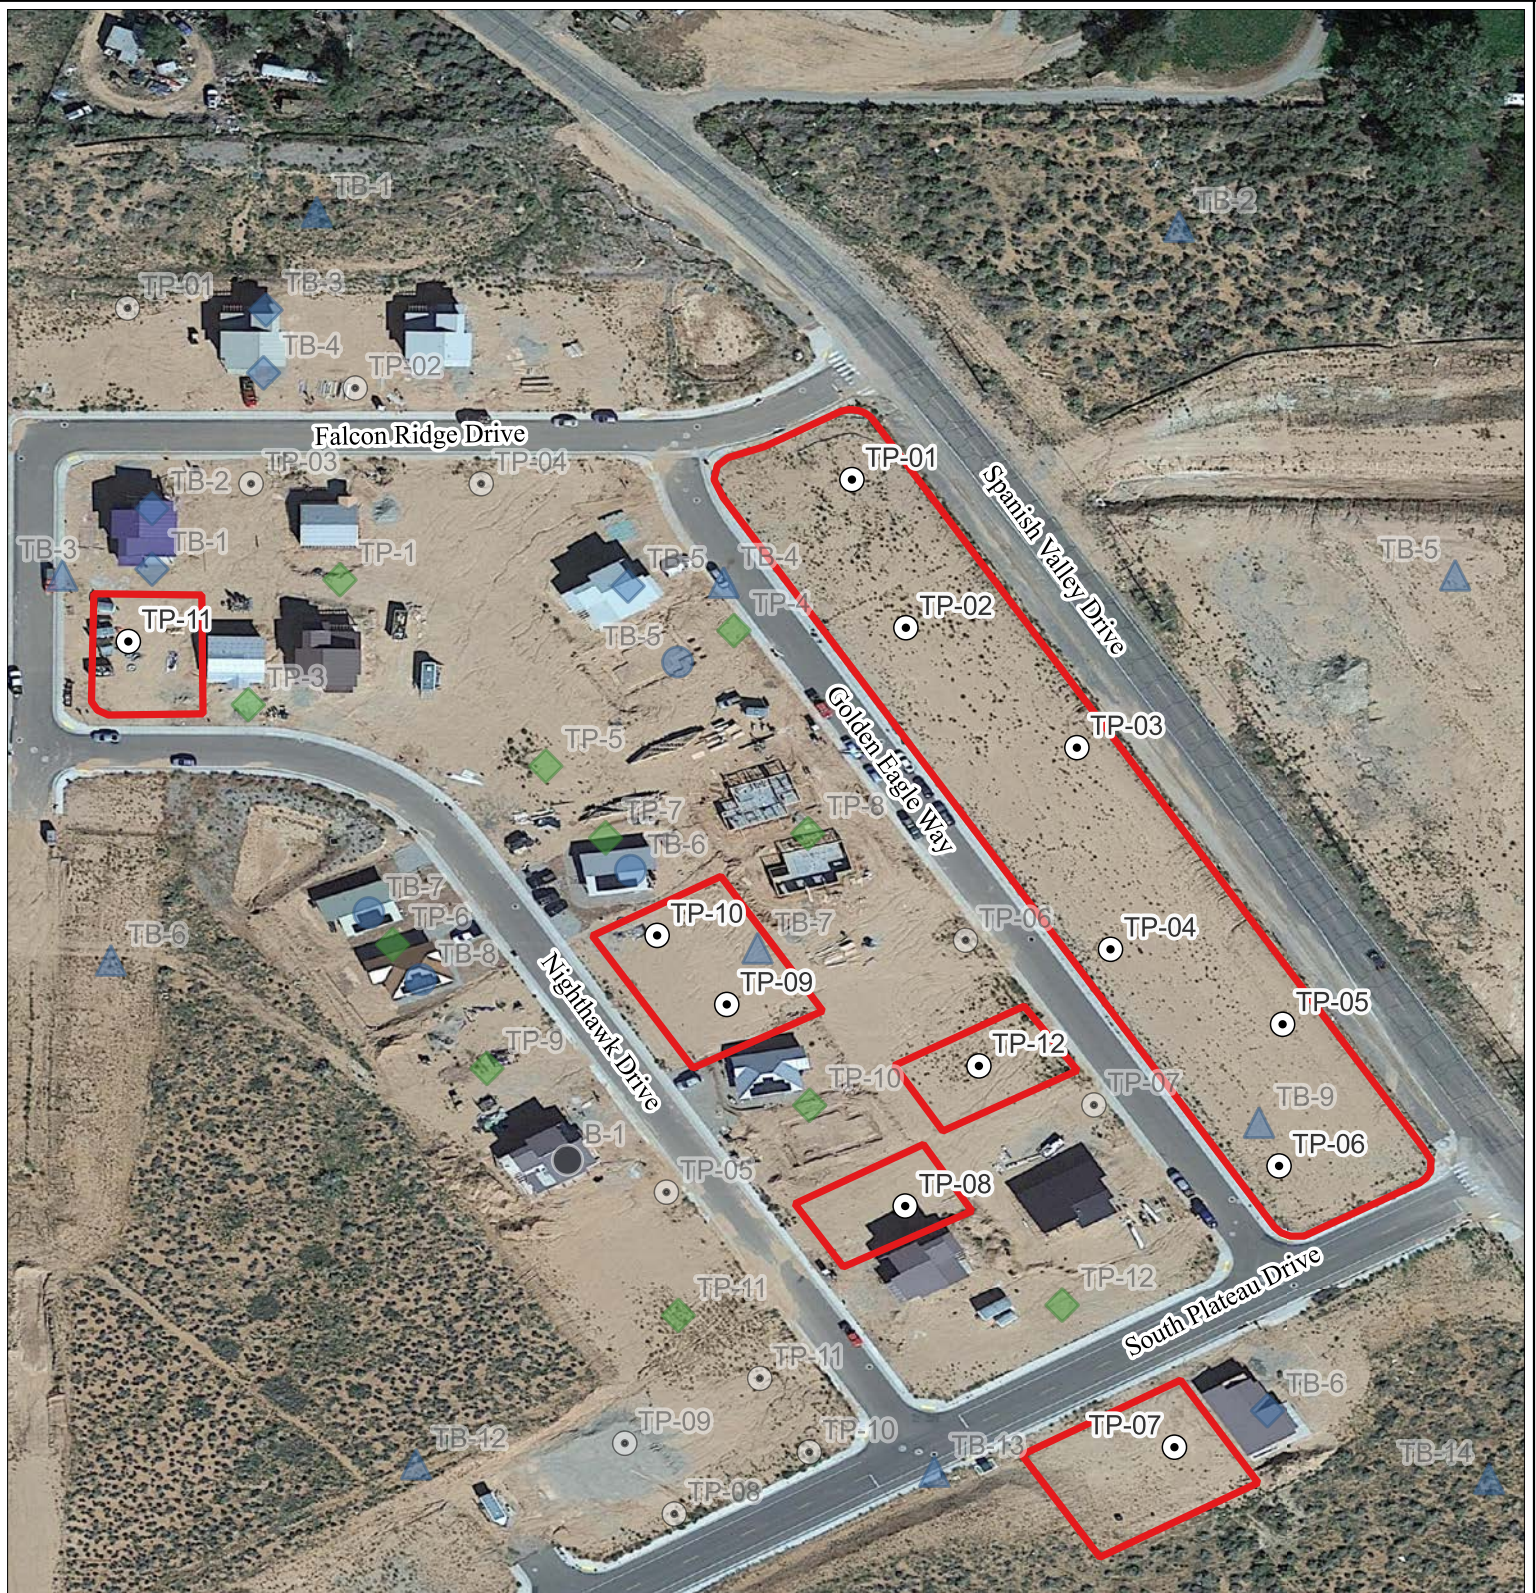
**FIG. 2a**

Several geotechnical investigations have previously been prepared for the Arroyo Crossing Development. The previous investigations were used as a reference for this investigation. TB-7 and TB-9 from Trautner Geotech's, *Feasibility Level Geotechnical Engineering Study / Design Level Pavement Recommendations – Arroyo Crossing Project*, are located within the project boundary. Relevant bore logs and laboratory testing are attached in Appendix C. Boring and test pit locations from previous investigations are marked in Figure 2a. The referenced reports include:
